Cisco DECT 6800 – Manual Firmware Upgrade Procedure

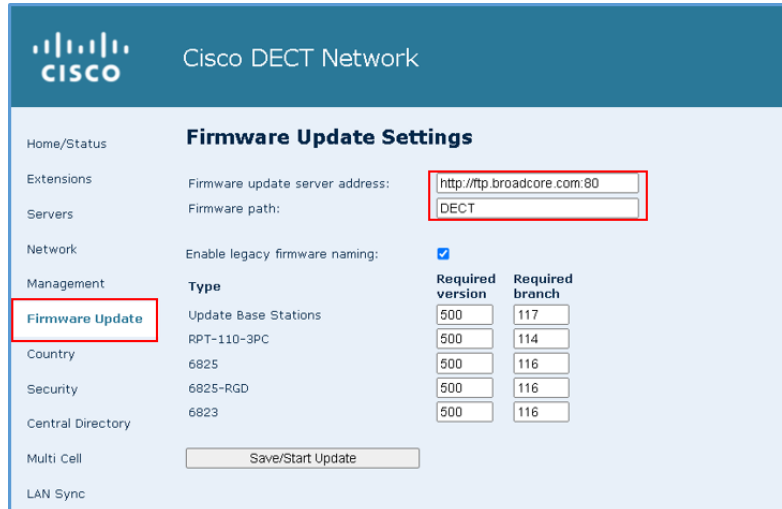
1. Browse each base station first and then go to "Firmware Update" page by selecting this page from the left panel.
2. Set the "Firmware update server address" to <http://ftp.broadcore.com:80> for US deployment and <http://config.masergy.com:80> for outside of the US

3. Set the "Firmware patch" to DECT

The screenshot shows the Cisco DECT Network Firmware Update Settings page. The 'Firmware Update' menu item is highlighted with a red box. The 'Firmware update server address' is set to 'http://tp.broadcore.com:80' and the 'Firmware path' is set to 'DECT'. The 'Enable legacy firmware naming' checkbox is checked. The 'Update Base Stations' section has a table with the following data:

Type	Required version	Required branch
Update Base Stations	500	117
RPT-110-3PC	500	114
6825	500	116
6825-RGD	500	116
6823	500	116

A 'Save/Start Update' button is visible at the bottom of the settings area.

9. When the upgrade of the base station is complete, return to the firmware update settings page and set the base station to the next firmware version level per the above-recommended path.
